## INVESTIGATION OF SURFACE WATER QUALITY OF THE BURIGANGA RIVER IN BANGLADESH: LABORATORY AND SPATIAL ANALYSIS APPROACHES

*Key words:* Surface water quality, Buriganga river, Laboratory and spatial analysis

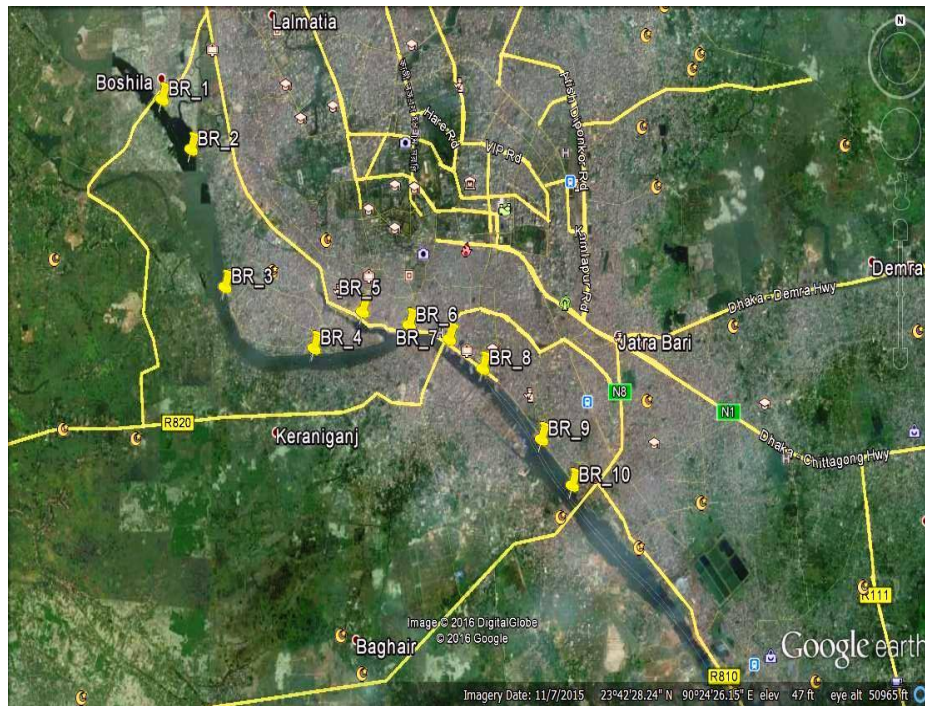
Fig. 2. Water sampling locations of the study area<sup>(8)</sup>.

Field investigation is important for evaluating any parameter of water quality. To conduct this work, ten water samples were collected from Buriganga river from ten different locations (upstream to downstream) (Fig. 2). Field works were conducted within the study area with sophisticated instruments such as handheld GPS, HANNA Pocket pH and Eh meter (model HI 98127), OAKTON waterproof pocket pH-EC comb. Meter (Model PC tester 35).
